Scientific article

HEATING CABLE AS A CAUSE OF FIRE DURING OPERATION OF THE DUST SUPPRESSION SYSTEM OF THE PRODUCTION AND RELOADING COMPLEX

For citation: Kleimanov P.A., Dzizyurov D.V., Borisov Ya.A. Heating cable as a cause of fire during operation of the dust suppression system of the production and reloading complex // Supervisory activities and forensic examination in the security system. 2023. № 2. P. 74–82.

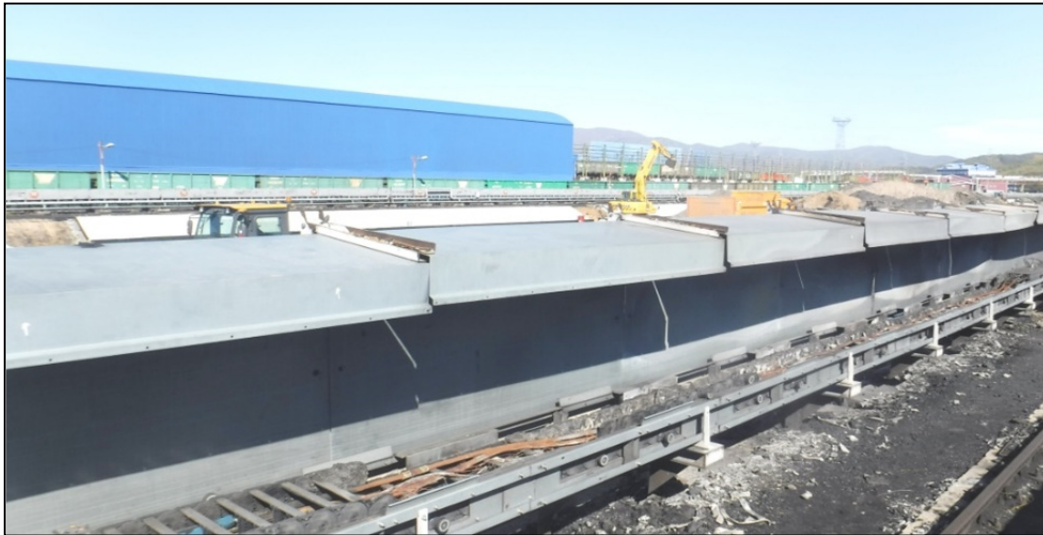
В ходе осмотра места пожара установлено, что в результате горения на участке пикет 32–33, на протяжении около 10 м произошло выгорание горючих материалов (изоляция проводников, тепловая изоляция, пластиковые элементы цепи) в двух уровнях кабельной цепи «Kabelschlepp», рукавов высокого давления, силового, управляющих и греющих кабелей. При возгорании отмечены участки с полным выгоранием горючих элементов кабельной цепи, расположенной сверху (второй от основания металлического лотка). Также изоляция проводников (силового, греющего и управляющих кабелей) на протяжении 10 м полностью выгорела (fig. 4).

Fig. 4. **Thermal damage to the section of the cable chain of the system dust suppression «Stacker»**

At the site closer to picket 33 in the upper level of the cable chain, a break in the power cable was found, a thinning of the metal sheath of high-pressure hoses, further towards the attachment point of the main to the «Staker» there is a section of the heating cable rupture, at the ends of the metal current-carrying conductors of which signs of a fire hazardous emergency operation of electrical equipment in the form of local melting were found (fig. 5, object under the number 3). This area with reflow is located in the most remote part from the power supply of the electrical circuit.

The degree of thermal damage to the cable chain and combustible materials of the cables indicates the spread of combustion from the 33rd picket towards the 31st picket.

The indicated place coincides with the zone of the greatest thermal damage, which additionally indicates that the fire was located precisely in the upper level of the cable chain of the Staker dust suppression system in the area closer to picket 33.

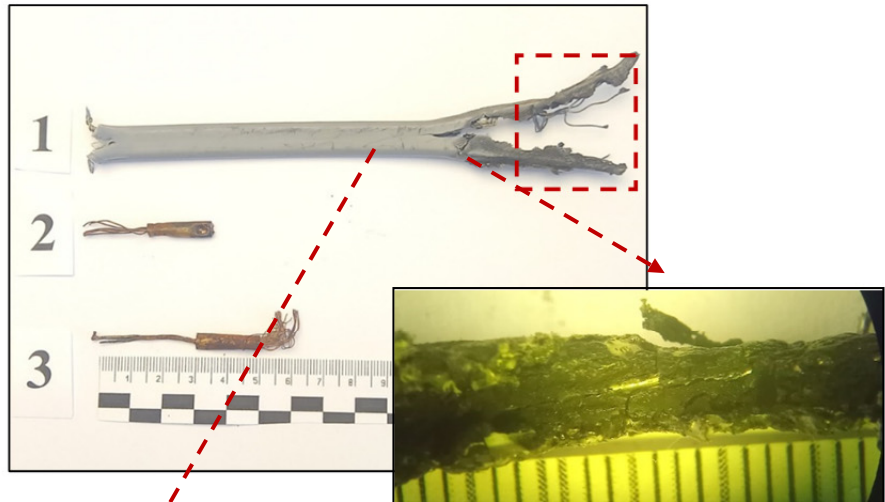
The object under the number 1 is a fragment of a heating self-regulating cable 177 mm long. A fragment of the conductor consists of: the outer layer of insulation is gray, then white insulation, then a semi-conductive self-regulating matrix of black color, then two white multi-wire cores with seven wires per core, the diameter of one wire is 0,5 mm. Two wires of one core were sintered in a local melting and three wires of the other core were also sintered in a local melting (fig. 5–9).

Fig. 5, 6. In the frame: 1 – a fragment of a heating cable with thermal damage insulation (matrix) from the side of the conductors; 2 – a burnt fragment of the connection of the heating and power conductor; 3 – a fragment of the connection of the heating and power conductor, local melting on the copper wires of the heating cable core (signs of a short circuit)

Thus, in the course of a visual study of a fragment of a heating cable, signs of emergency operation of electrical equipment were found, which are characteristic of the occurrence of a short circuit current and overcurrent overload as a result of an electric arc.

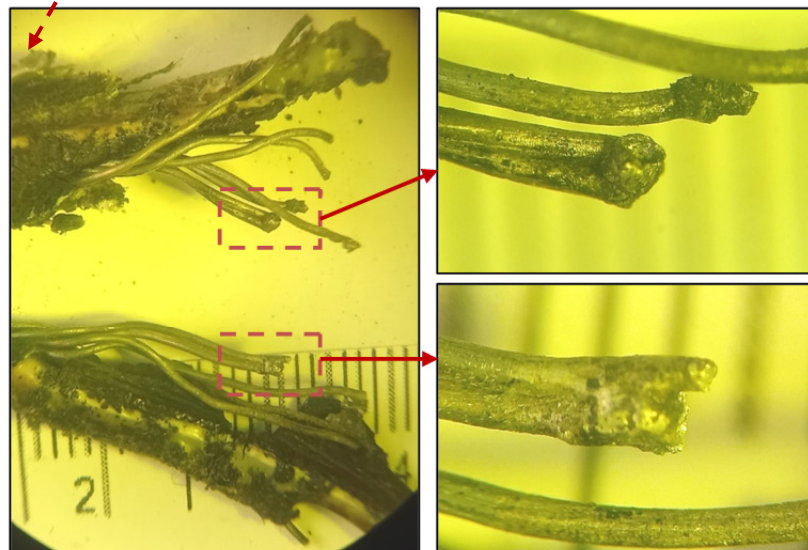
Fig. 7–9. Enlarged image of a fragment of a heating cable with melting on the core wires

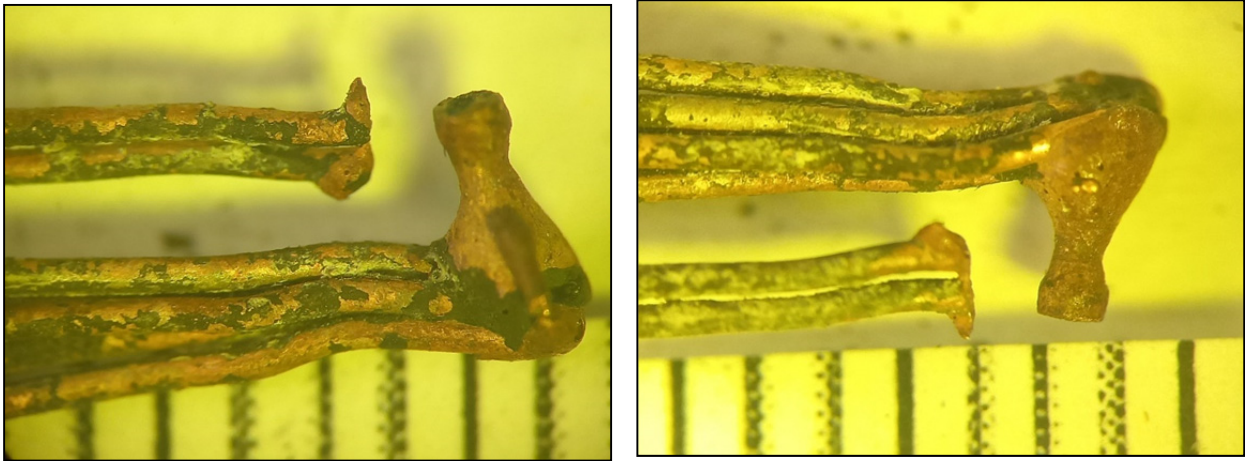
The object under the number 3 is a fragment of a cylindrical metal sleeve 20 mm long, 5 mm in diameter, on one side of the sleeve a multi-wire copper core 32,7 mm long departs from the sleeve, six wires in the core with a diameter of 0,46 mm each, four wires were sintered in local melting dimensions 2,5x3,7x2,5 mm. From the other end of the sleeve, a copper stranded conductor 21 mm long departs, 33 wires in the conductor, the diameter of one wire is 0,27 mm, five wires are sintered in local melting (fig. 5, 10, 11).

Fig. 10, 11. Enlarged image of melting on the copper wires of the heating cable № 3

Thus, during the visual examination of object № 3 – a fragment of a copper conductor (a metal sleeve with fragments of copper conductors of a heating and power cable), signs of emergency operation of electrical equipment were found on the copper conductor of the heating cable, characteristic of a short circuit as a result of an electric arc current.

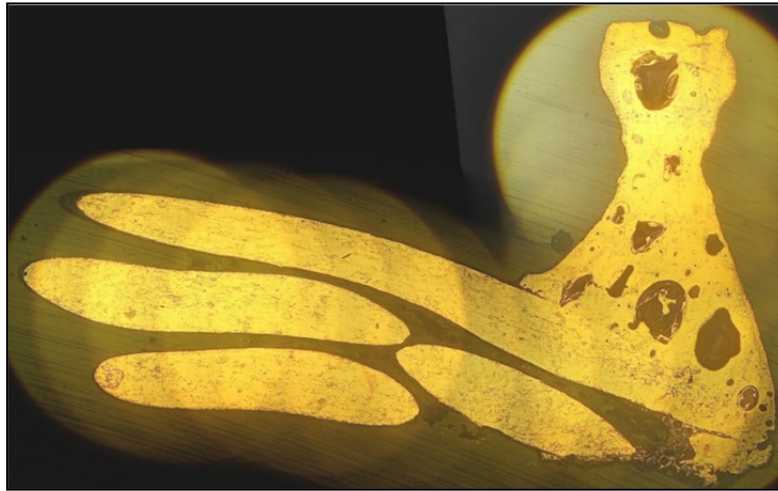
A study using a metallographic microscope of the indicated melting has established that in the zone of the conductor part the basis of the microstructure is copper (light areas), small equiaxed grains are observed along the boundaries and inside the copper grains in the form of dark dots – copper oxide I (Cu_2O). In the melting zone, the microstructure of the melting zone is based on medium elongated grains, there is a clear straight boundary between the melting zone and the conductor part (fig. 14).

In the course of the metallographic study of object № 3 – a fragment of the copper conductor of the heating cable, it was found that the microstructure of the conductor part has small equiaxed copper grains, a direct boundary between the microstructures of reflow and the conductor part is observed, the microstructure of reflow has medium elongated copper grains. These signs are typical for a short circuit that occurred before the fire.

Fig. 14. Panoramic shot of the microstructure of the reflow of the object № 3, (100^x)

Thus, taking into account the studies carried out, taking into account the location of the fire, the cause of the fire was the ignition of combustible materials (wire insulation, thermal insulation) due to fire hazardous emergency operation of electrical equipment – a heating cable system located in the moving part of the cable circuit of the dust suppression system «Stacker».

Therefore, when designing, installing and operating electrical installations, it is necessary to strictly comply with the requirements of regulatory and technical documentation, and the state fire supervision authorities should pay more attention to the problem of violating the rules for their operation in the field of fire safety.
