Scientific article

HEATING CABLE AS A CAUSE OF FIRE DURING OPERATION OF THE DUST SUPPRESSION SYSTEM OF THE PRODUCTION AND RELOADING COMPLEX

For citation: Kleimanov P.A., Dzizyurov D.V., Borisov Ya.A. Heating cable as a cause of fire during operation of the dust suppression system of the production and reloading complex // Supervisory activities and forensic examination in the security system. 2023. № 2. P. 74–82.

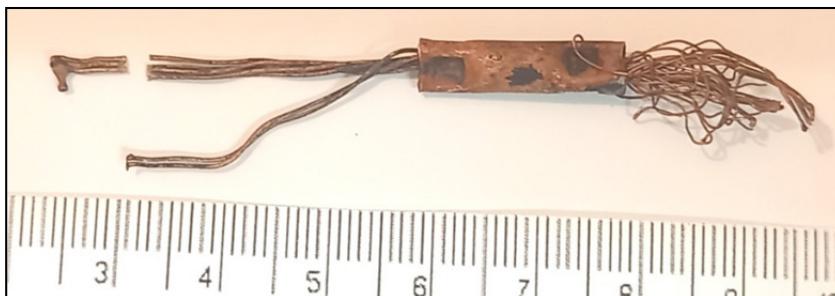
From the fragment with melting of object № 3, a section with melting 9 mm long was cut off, from which a microsection was prepared (fig. 12). To do this, a round frame was installed on the glossy surface of the ceramic plate, in which a segment was placed.

Fig.12. Section with melting, separated from object № 3 for metallographic examination

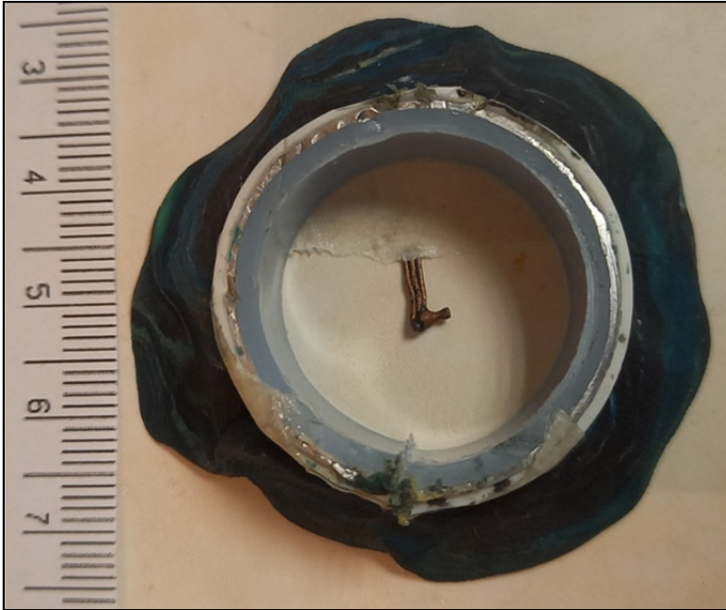
With reflow (fig. 13). The frame was filled with self-hardening plastic «Protacryl-M» (hardening time – 60 min).

Fig. 13. Piece with melting in the frame
